Re: Town of Taos Ski Valley Wastewater Treatment Plant; Major Municipal Permit; SIC4952; NPDES Compliance Evaluation Inspection; NM0022101; February 11, 2016

Village of Taos Ski Valley Wastewater Treatment Plant Compliance Evaluation Inspection NPDES Permit Number NM0022101 11 February 2016 Page 1 of 6

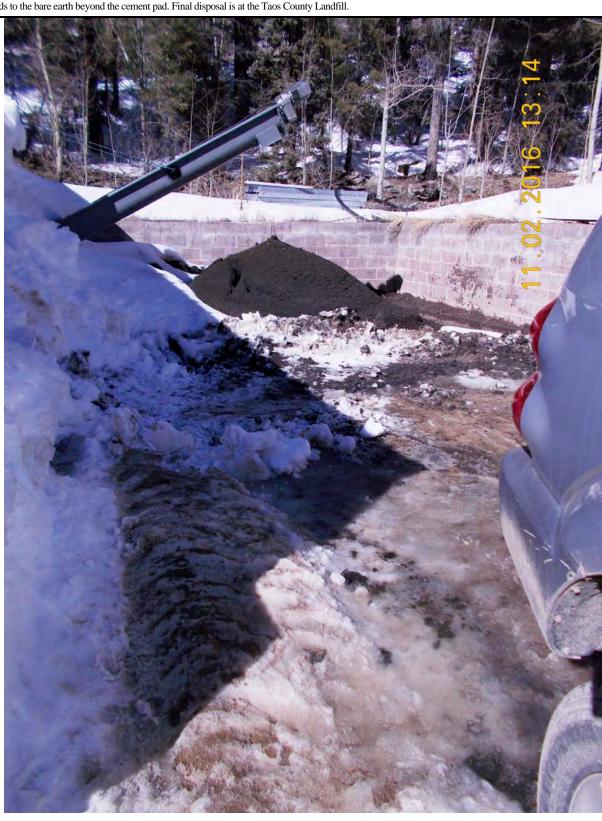
NMED/SWQB Official Photograph Log Photo #6		
Photographer: B. Cooney Date: February 11, 2016		Time: 13:14 Hours
City/County: Town of Taos Ski Valley / Taos State: New Mexico		State: New Mexico

Subject: Dried and processes sludge is carried by a conveyor belt and deposited either in a dump truck or on the cement pad sloped to prevent run off. However, trackout can carry solids to the bare earth beyond the cement pad. Final disposal is at the Taos County Landfill.

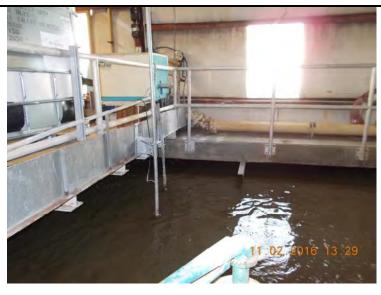
NMED/SWQB Official Photograph Log Photo #7		
Photographer: B. Cooney	Date: February 11, 2016	Time: 13:29 Hours
City/County: Town of Taos Ski Valley / Taos		State: New Mexico
Town of Taos Ski Valley Wastewater Treatment Plant Location:

Subject: Activation Basin 1 (AB1) of the activated sludge process is where the Poly Aluminum Chloride is added for Total Phosphorous removal and where pH adjustment is made to maintain at 7.6 su, with soda ash.

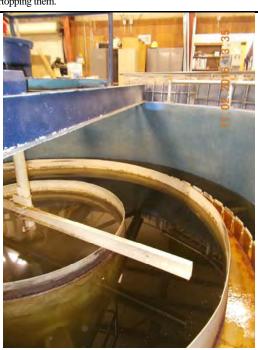
NMED/SWQB Official Photograph Log Photo # 8 Photographer: B. Cooney Date: February 11, 2016 City/County: Town of Taos Ski Valley / Taos State: New Mexico

Subject: The two secondary clarifies are 12 feet deep and the sludge blanket was 3.2 feet and 4.0 deep at the time of the inspection. Both clarifiers have slightly uneven weirs though there was no evidence of excessive solids overtopping them.

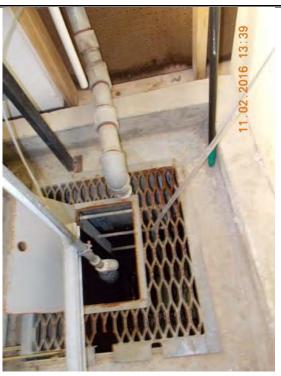
Subject: Effluent water then enters a flow measuring unit consisting of a square weir box which includes a 45° V-notch weir with a staff gauge. The staff gauge, affixed to the side of the square weir box was not easily visible. A secondary ultrasonic flow measuring device is used for reporting purposes. The ultrasonic flow meter gives both an instant flow and totalized flow reading.

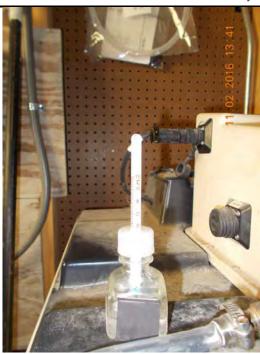
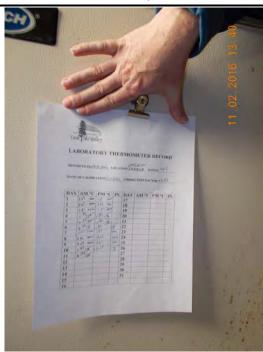
NMED/SWQB Official Photograph Log Photo # 11& 12

Subject: Effluent compost samples collected by an ISCO auto-sampler. The temperature is taken daily and logged on the sheet on the door of the unit. There is an internal sensor and a second thermometer. The second thermometer should be checked yearly against a calibrated thermometer and any correction should be noted.

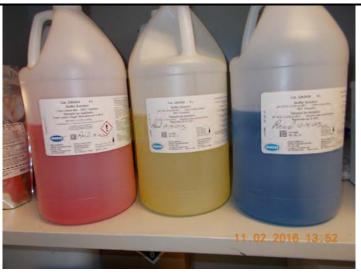
NMED/SWQB Official Photograph Log Photo # 13		
Photographer: B. Cooney	Date: February 11, 2016	Time: 13:52 Hours
City/County: Town of Taos Ski Valley / Taos State: New Mexico		State: New Mexico
Location: Town of Taos Ski Valley Wastewater Treatment Plant		
Subject: pH buffer are labeled and the date received is written on the bottles. The bottles stored in a cabinet and used before the expiration date.

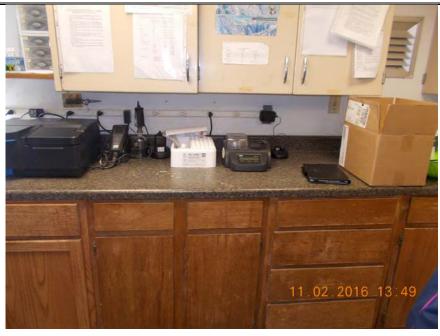
NMED/SWQB Official Photograph Log Photo #14		
Photographer: B. Cooney Date: February 11, 2016 Time: 13:49 Hours		
City/County: Town of Taos Ski Valley / Taos State: New Mexico		State: New Mexico
Location: Town of Taos Ski Valley Wastewater Treatment Plant		
Subject: Laboratory bench with DO meter. The laboratory though clean, is very small and there is little room to work.

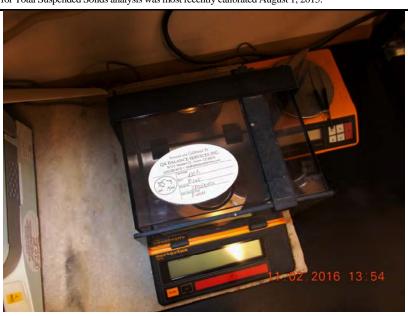
NMED/SWQB Official Photograph Log Photo # 15		
Photographer: B. Cooney	Date: February 11, 2016	Time: 13: 54 Hours
City/County: Town of Taos Ski Valley / Taos State: New Mexico		State: New Mexico
Location: Town of Taos Ski Valley Wastewater Treatment Plant		
Subject: The laboratory scale used for Total Suspended Solids analysis was most recently calibrated August 1, 2015.

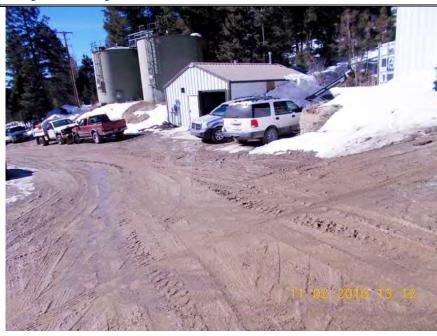
NMED/SWQB Official Photograph Log Photo # 16		
Photographer: B. Cooney Date: February 11, 2016 Time: 13:12 Hours		
City/County: Town of Taos Ski Valley / Taos		State: New Mexico
Location: Town of Taos Ski Valley Wastewater Treatment Plant		
Subject: Above ground sludge holding tanks in the background.
